Fig 7-B

THE BLEICHERT ROPEWAY OR PENDANT TRAMWAY

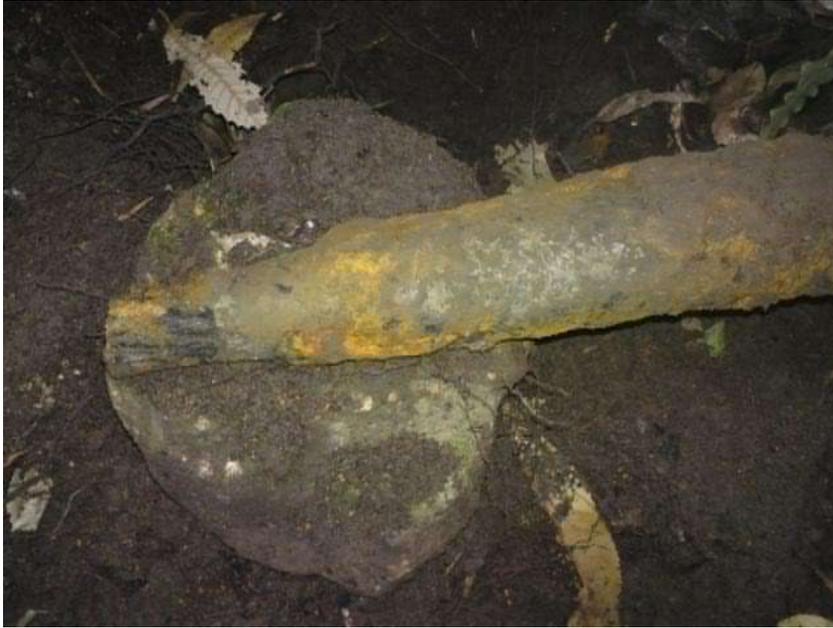
Fig 7-A

There is a socket at the end of the bar FIG 7-A into which is a 30mm diameter piece of inbound rope.. Unfortunately this particular part of the rope fell very close to a creek bed, so it has been constantly wet for the past 109 years, and the rope is very corroded.

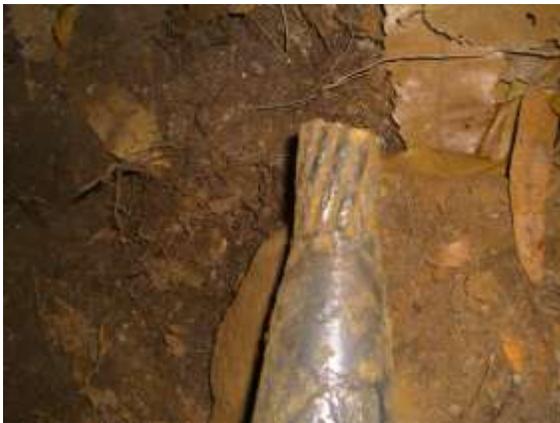
A further expedition on Fri 8th May 2009, we cleaned up the rope end and socket. The rope appears to have been cut. Fig 7-C & 7-D.

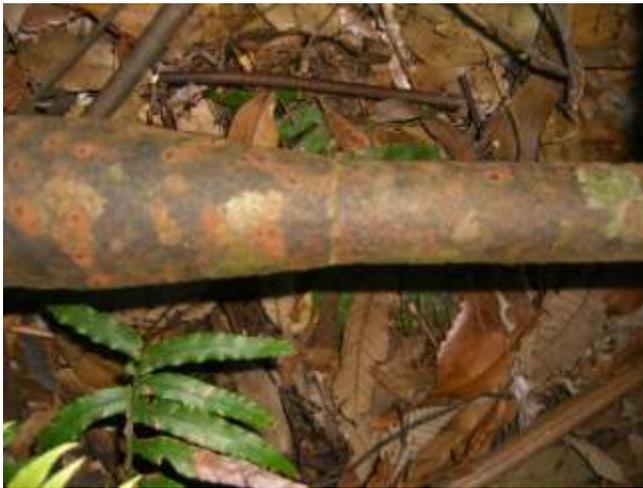
This is the point of insertion of the rod into the socket. Fig 7-E

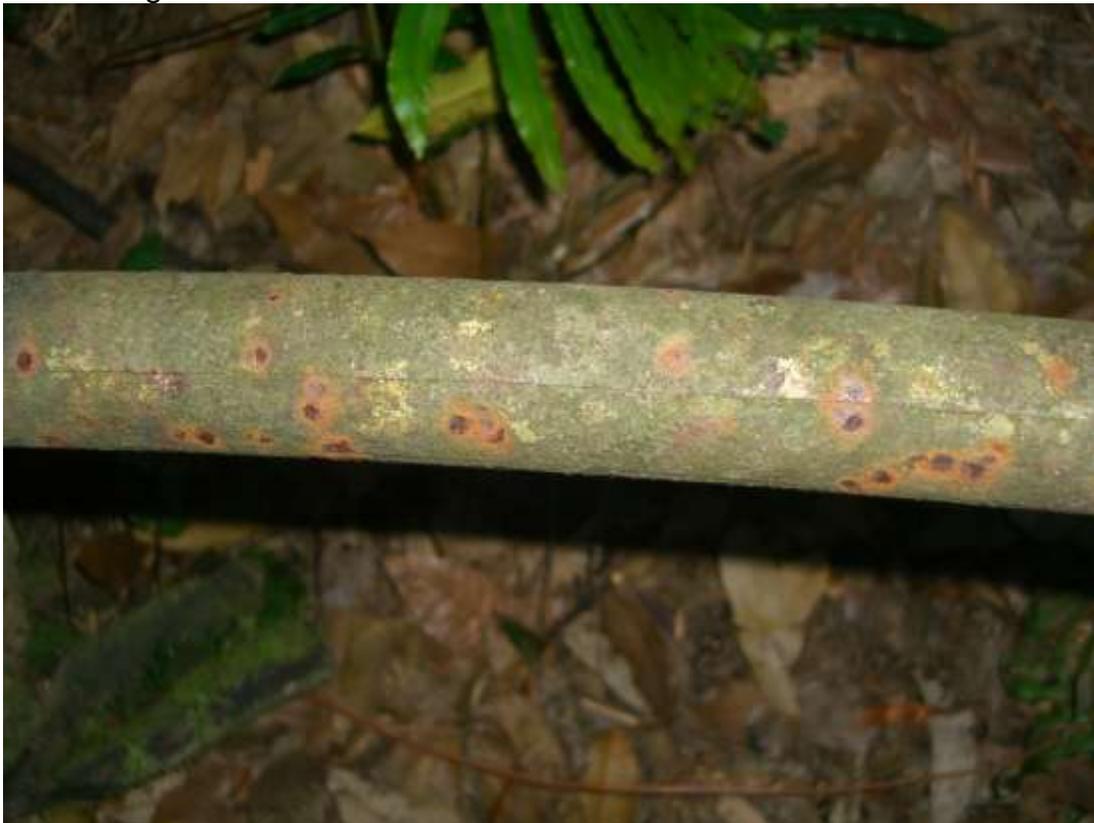
We also took some measurements of the bar that was used to replace the track rope. It was 35 mm diameter (same as the rope it replaced because it had to fit into the existing joining sockets) and was in two lengths one of 17 M and one of 22 M. The bar had a single small ridge running along its length. Fig 7-F We propose that this is a result of the rolling method used to produce the rod.

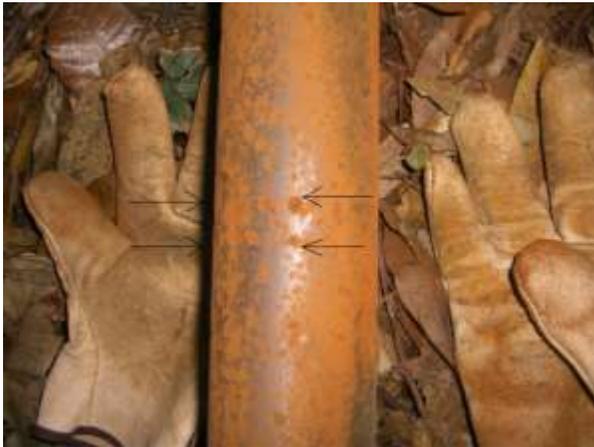
The bar had been joined by utilising the standard Bleichert rope joiners. New internally threaded sockets would have to be made to accept the bar and the threaded insert. The two halves are then screwed together with a right hand/left hand threaded insert and kept in place by a whitemetal plug. You can see the faint two lines of the edge of the insert in the LH photo Fig 7-G and the hole for the 'C' spanner to tighten it all up in the RH photo. Fig 7-H.

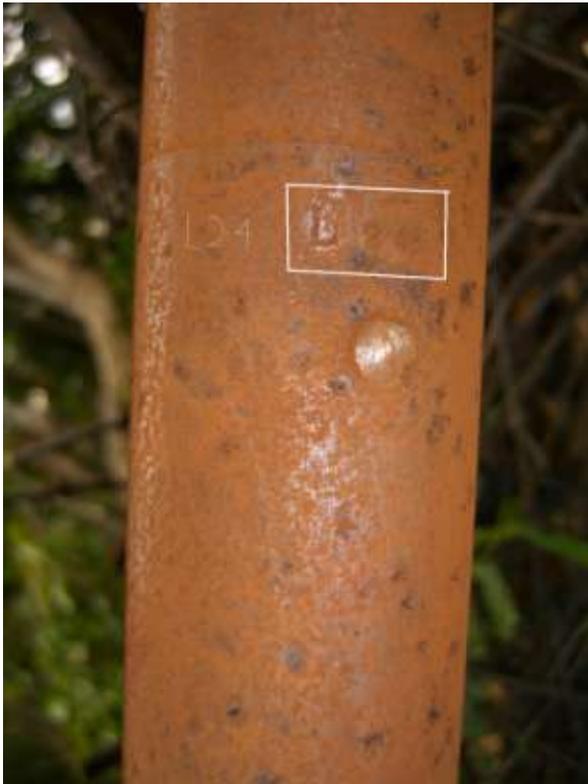
Here is a photo of the tip of the whitemetal plug from another joiner further down the inbound rope.

The small shiny plug is in the centre of the picture.

There is also a part number stamped on the socket L 25. We assume L for "links" or left hand thread and 25 for the size of the thread in mm.

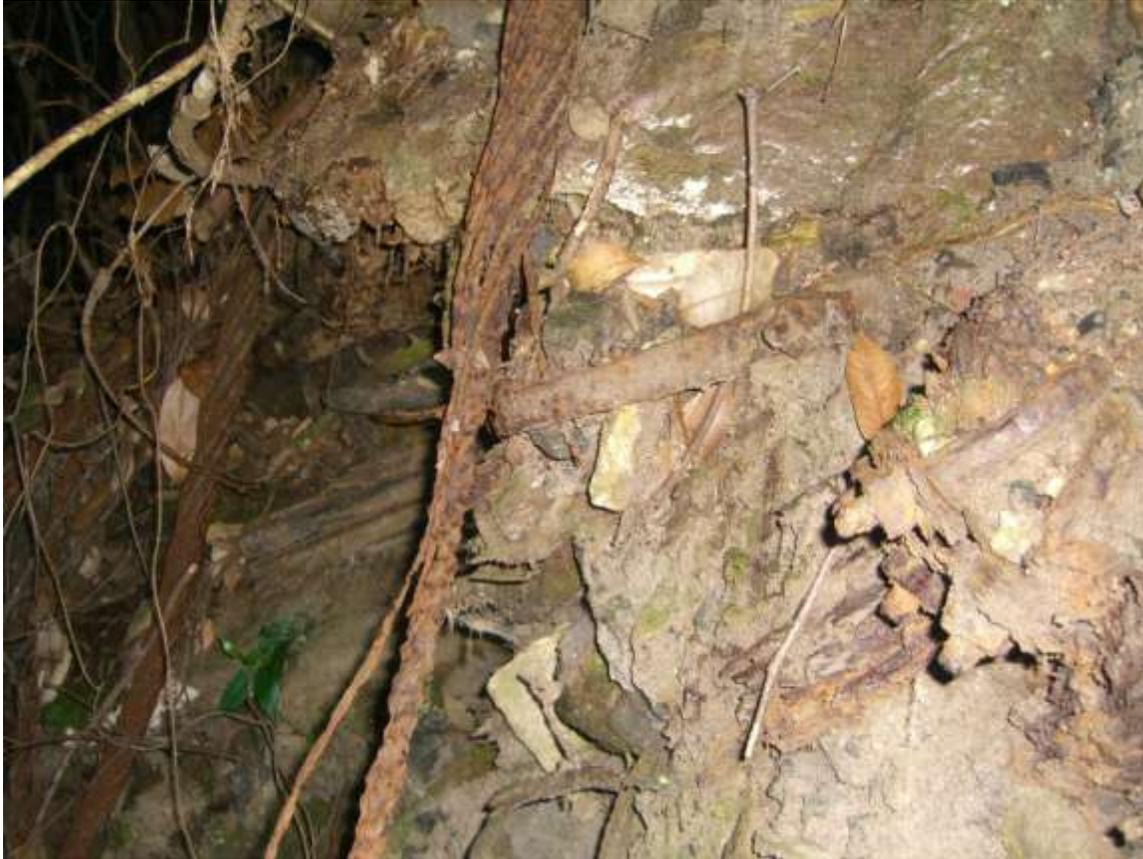
There is a broken off piece of rope lying beside the Scenic Railway track 100 feet below this point, partially buried. The terminating bolt, the right hand one in fig 7-B was found lying beside it in the creek bed. The rope has maybe 20 rope clips on it all jammed up together and the remains of a sling. See FIG 7-C

The clips are on the RHS of the picture.

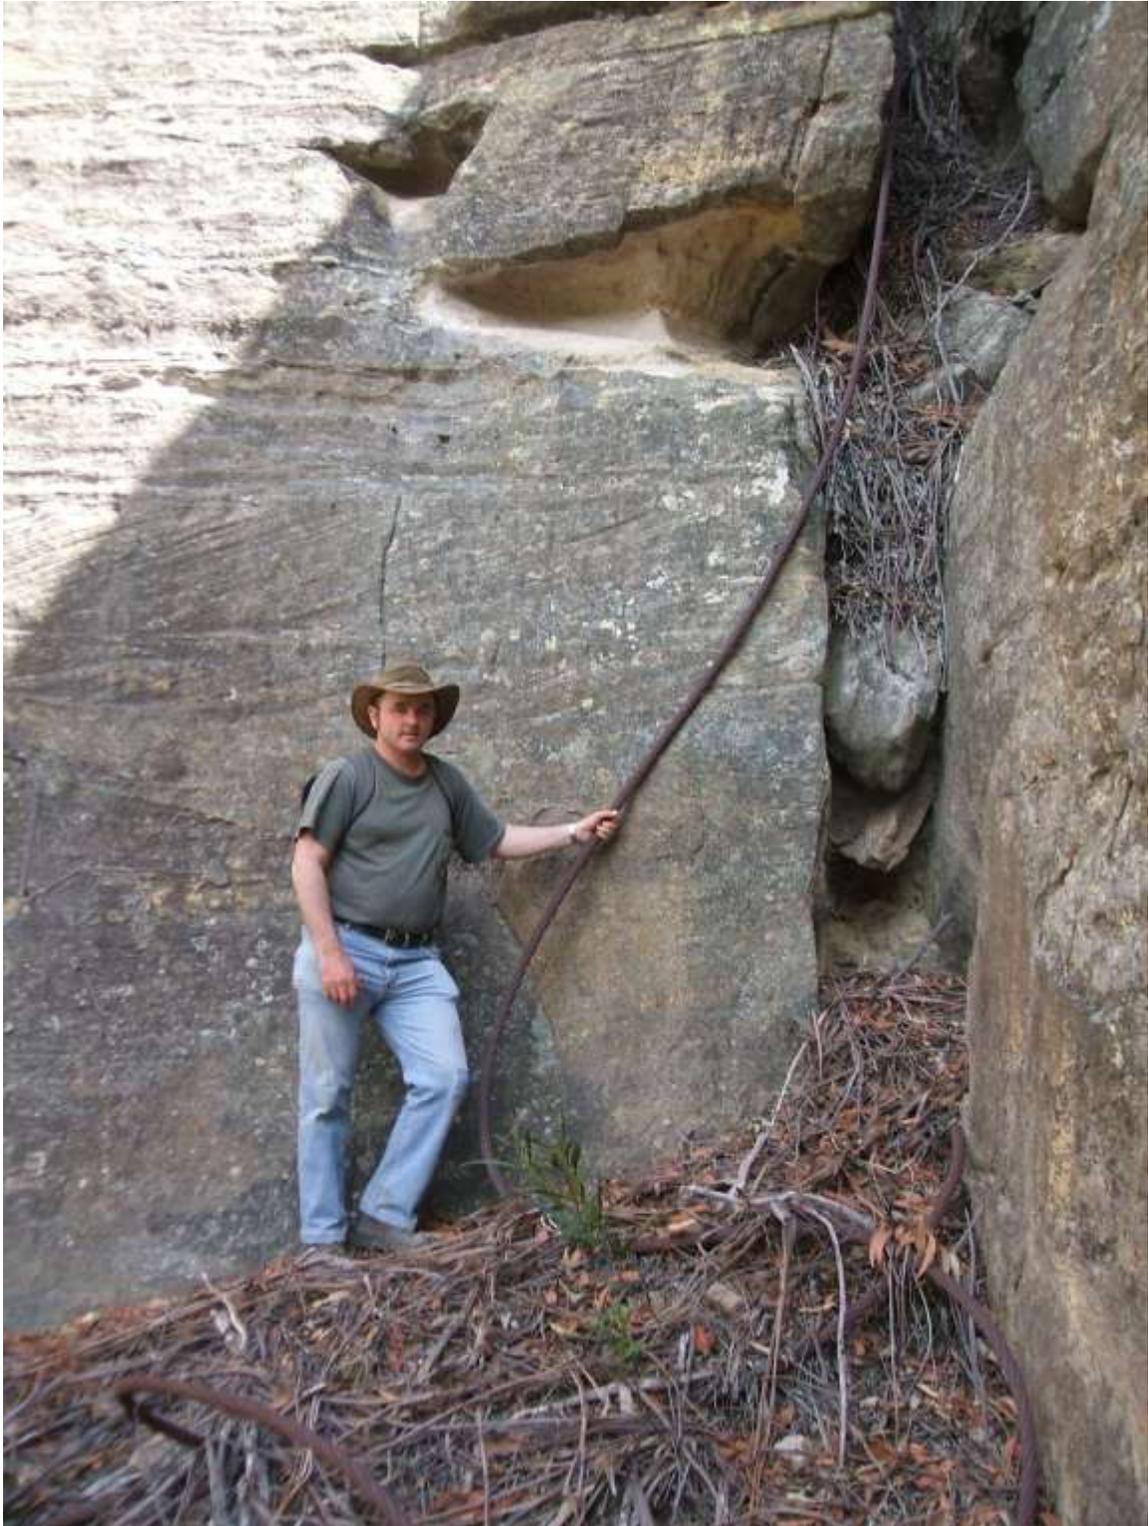
We have photographs of an aerial ropeway at Capertee FIG 7-E which was used to bring timber down from the plateau. I haven't measured the rope yet, but the rope looks like it could be Bleichert rope. We have yet to account for the missing 100 M of outbound rope at the Southern end of the ropeway. It is possible that when the Northern recovery failed, the rope was recovered from the southern end, as the tramway was still active and the rope could be brought out in 40 M sections on the tramway, just dragging along the ground, hitched to the haul rope.
