Chapter 11

William Hocking's accident. Page 149

"The chain in front of a full coal skip"

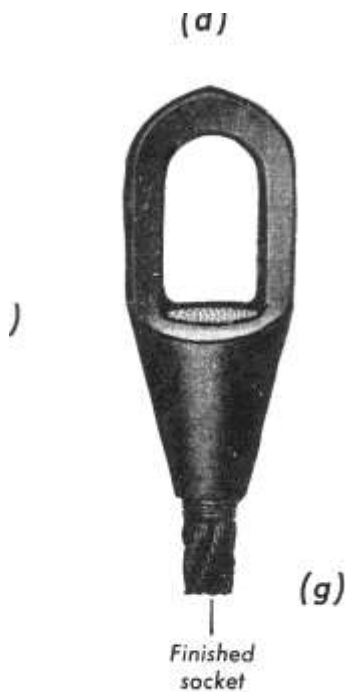
The tail of the haulage rope was attached to the hook on the back of the topmost skip using a whitetail closed socket. The socket was either placed directly over the hook or a forged ring was used. If rope twist was a problem, which could potentially de-rail the lightweight skips, a swivel was used between the socket and the hook.

There was usually a safety bar which was twisted across the gap in the hook to prevent the ring from coming out of the hook if the rope went slack for any reason.
